**PRECAUTIONARY MEASURES TAKEN UPCOMING NORTH EAST MONSOON**

Additional Chief Engineer,  
DEDC/Dharmapuri.

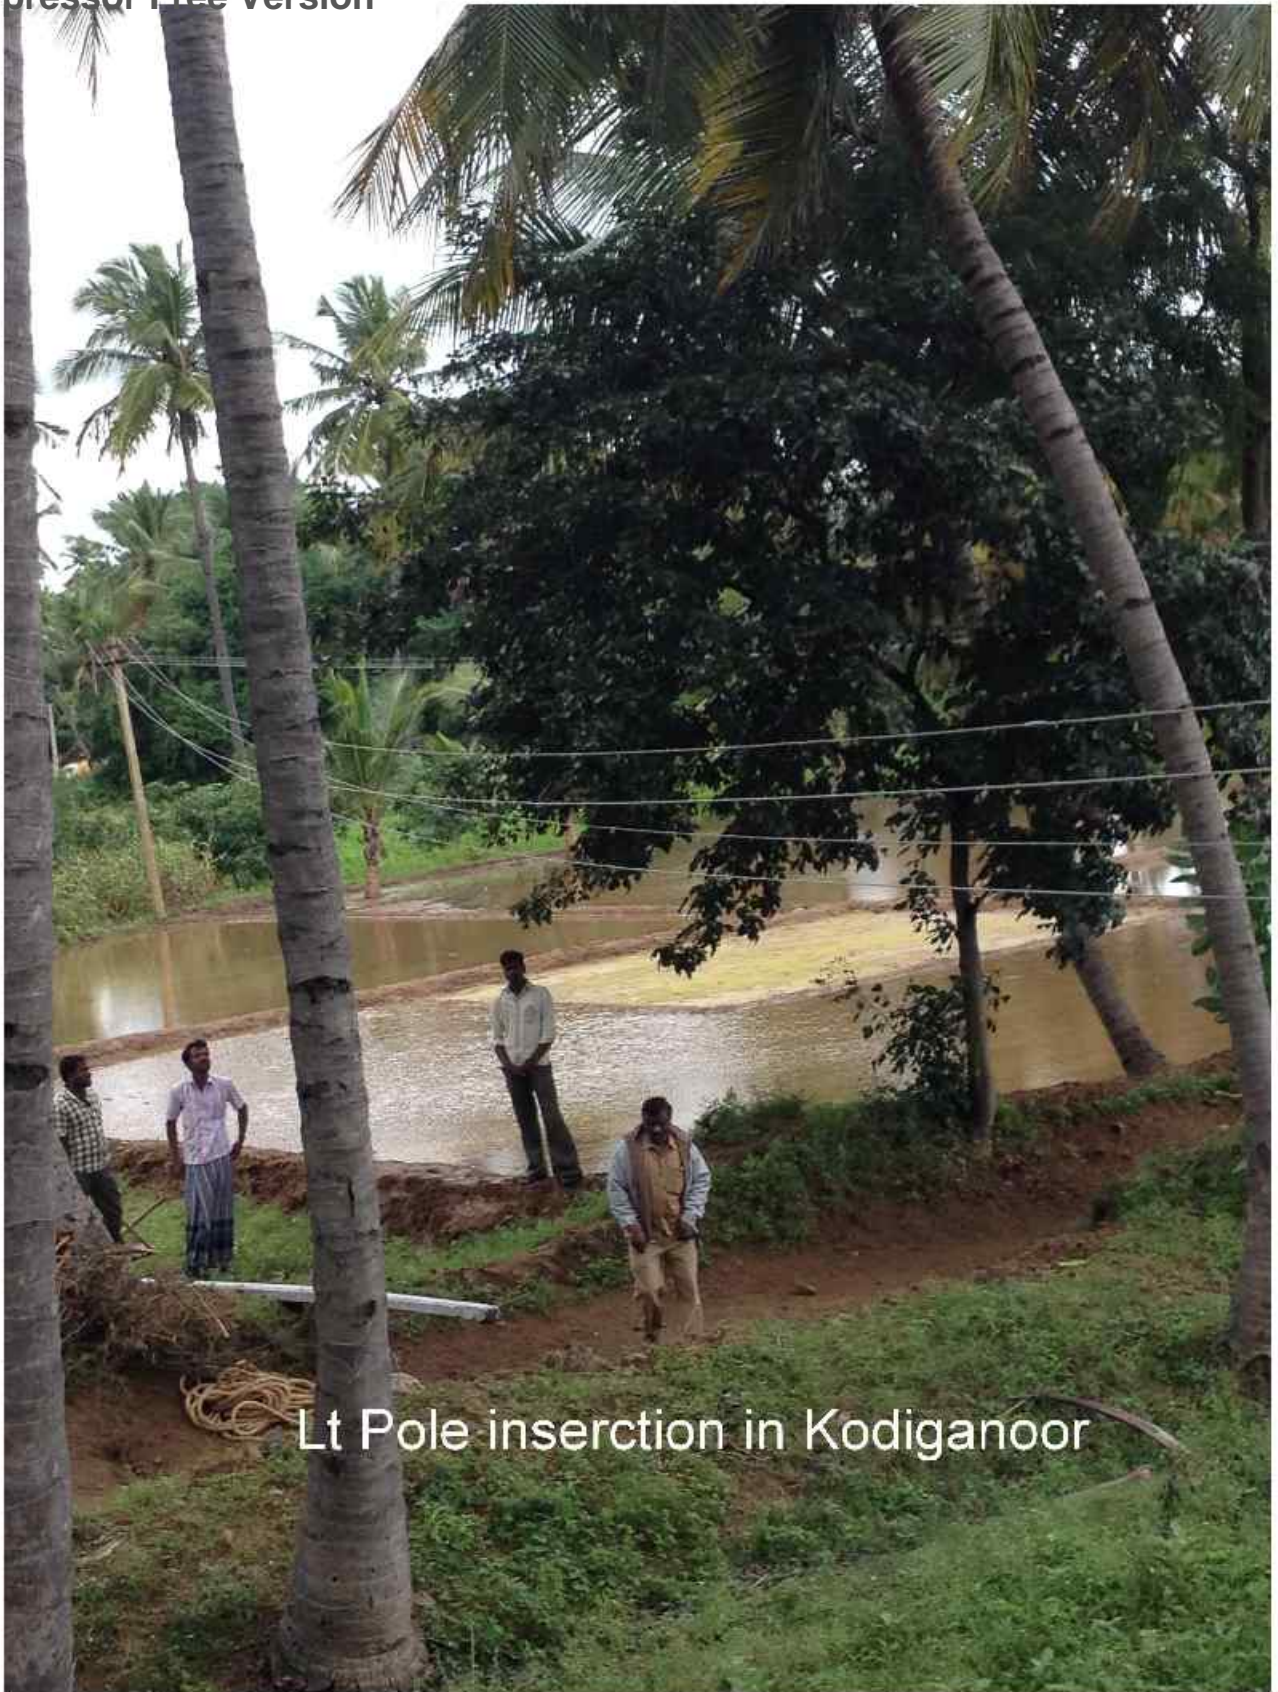
Lt Pole inserction in Kodiganoor

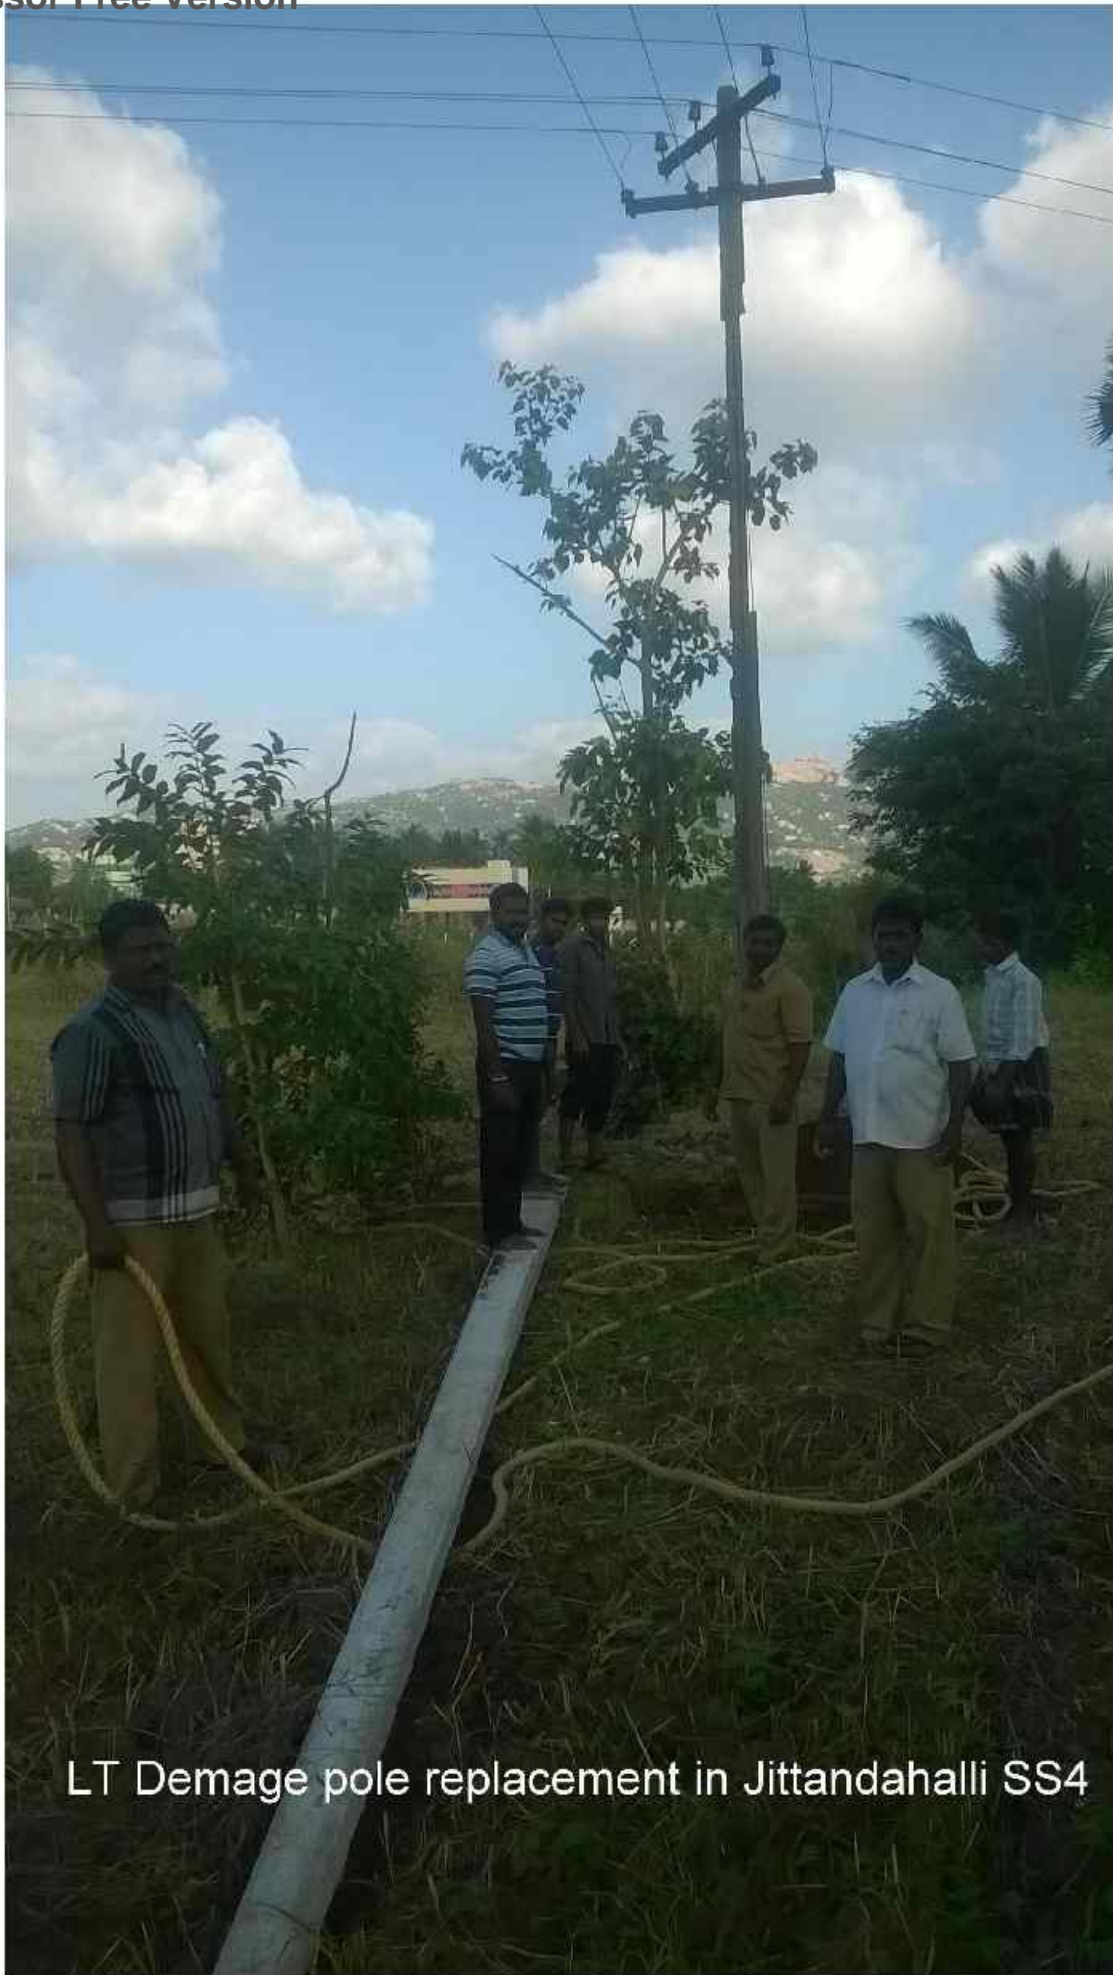
LT Damage pole replacement in Jittandahalli SS4

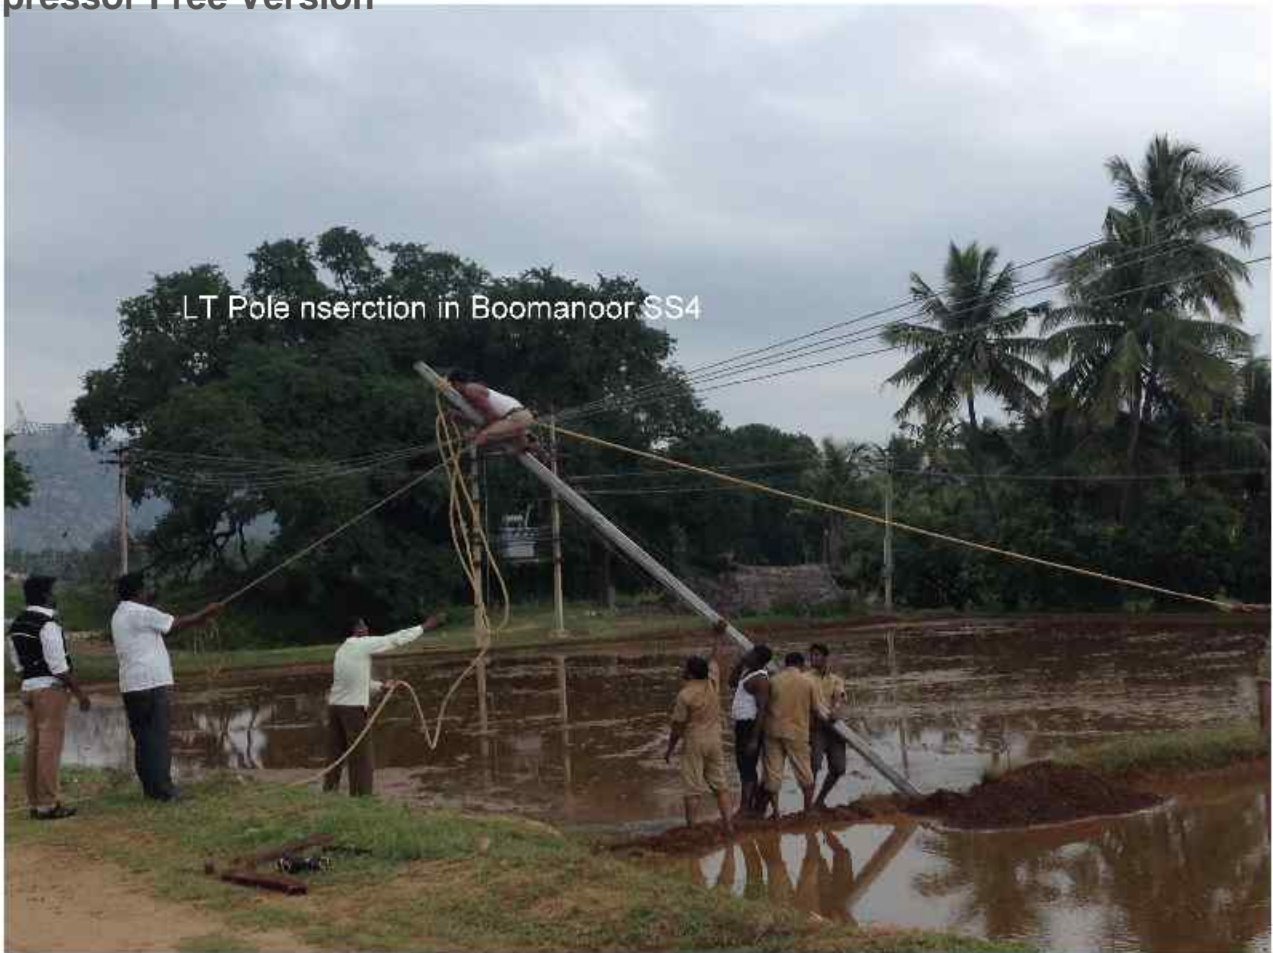
LT Pole nserction in Boomanoor SS4

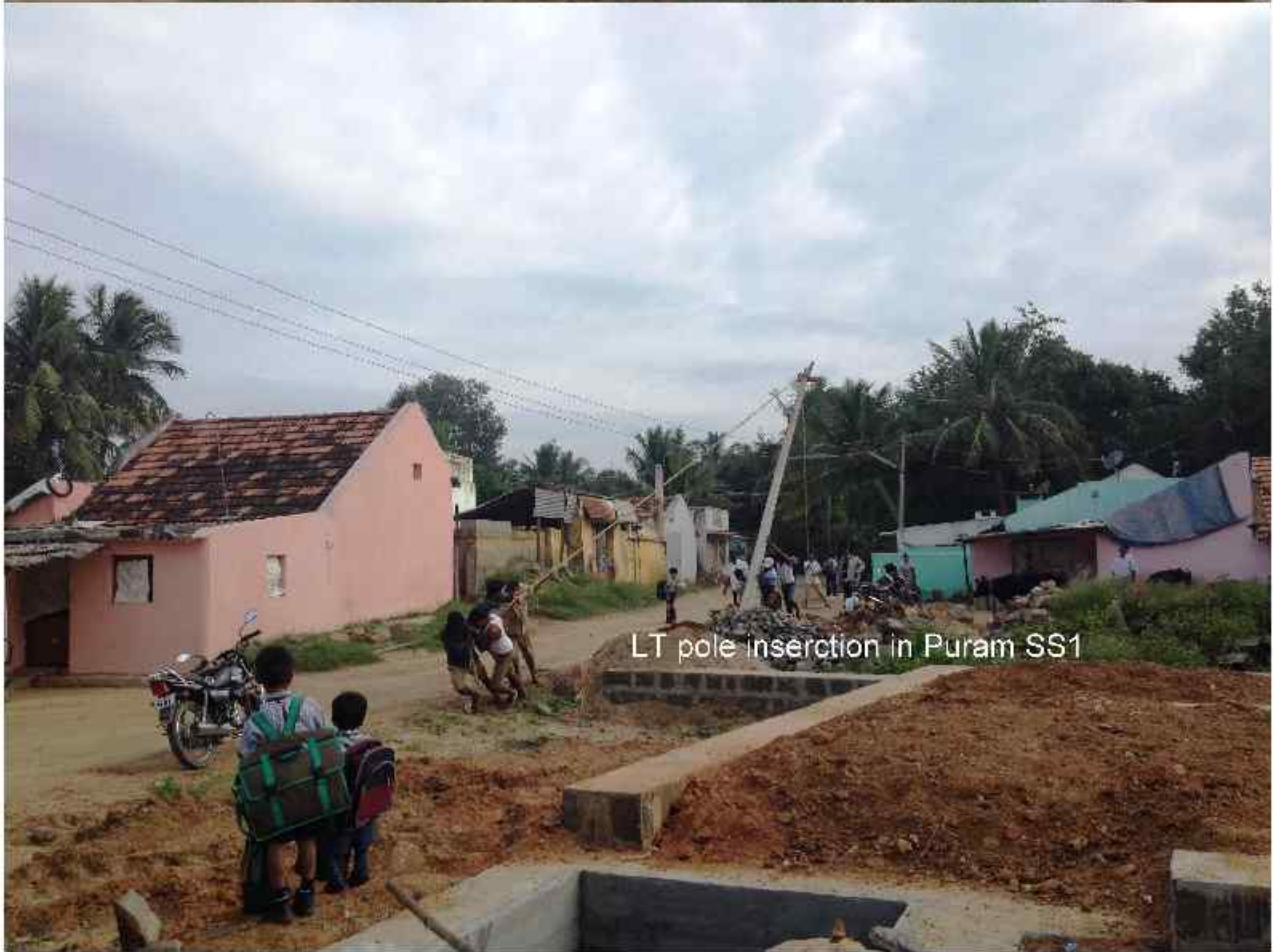
LT pole insertion in Puram SS1

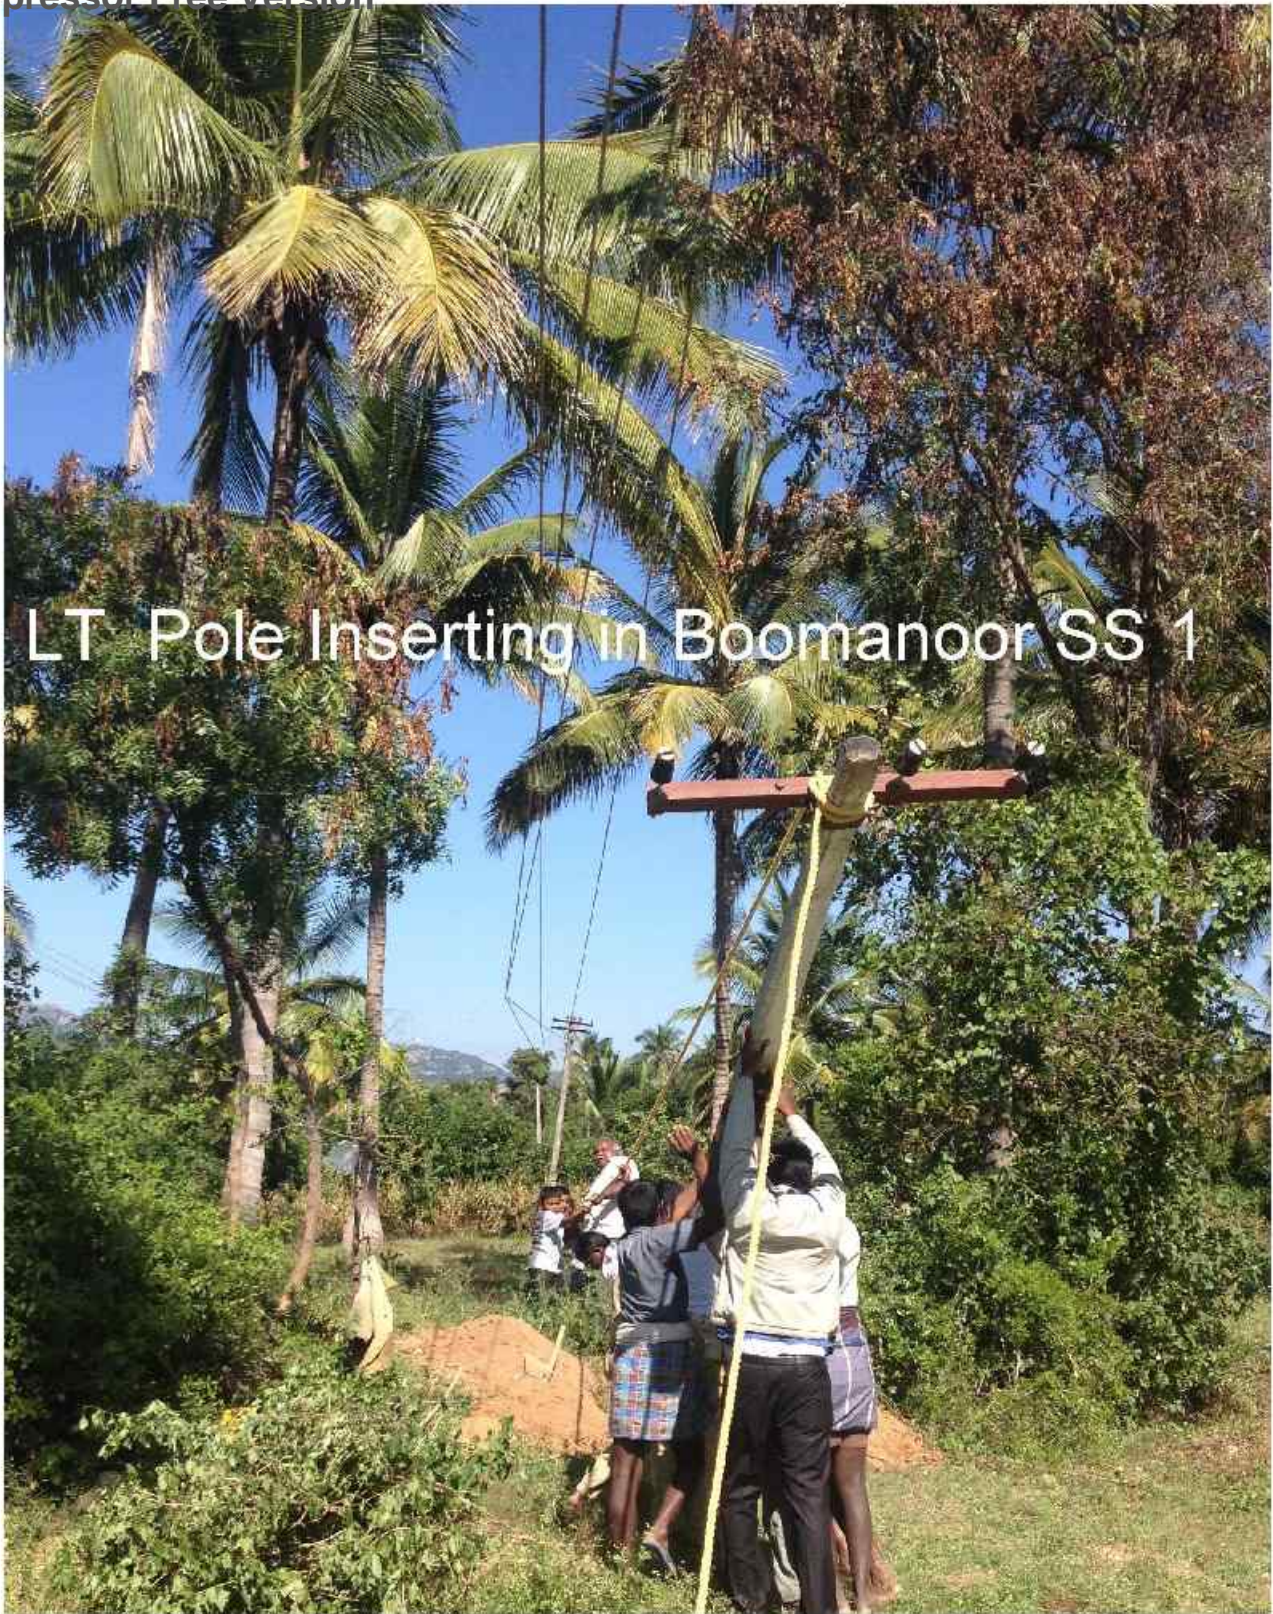
LT Pole Inserting in Boomanoor SS 1

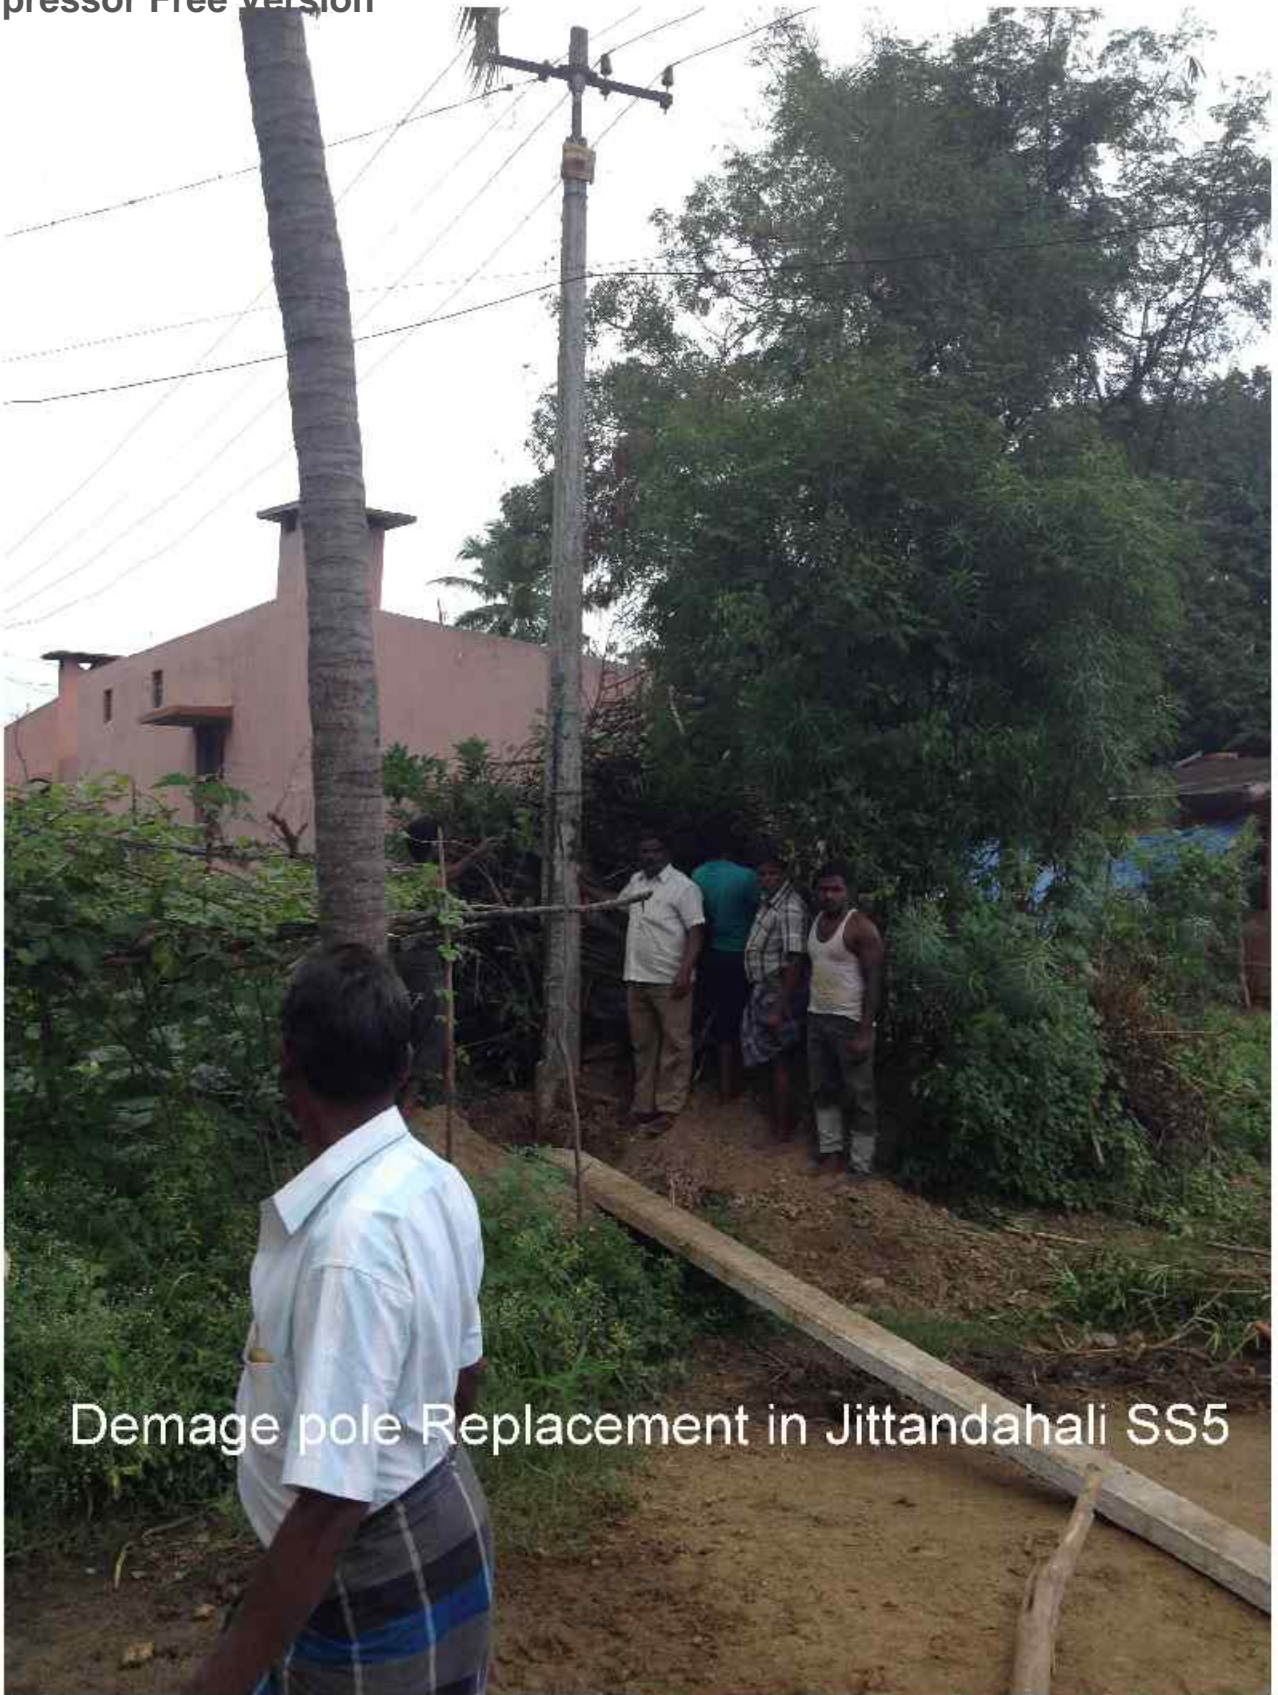
Demage pole Replacement in Jittandahali SS5

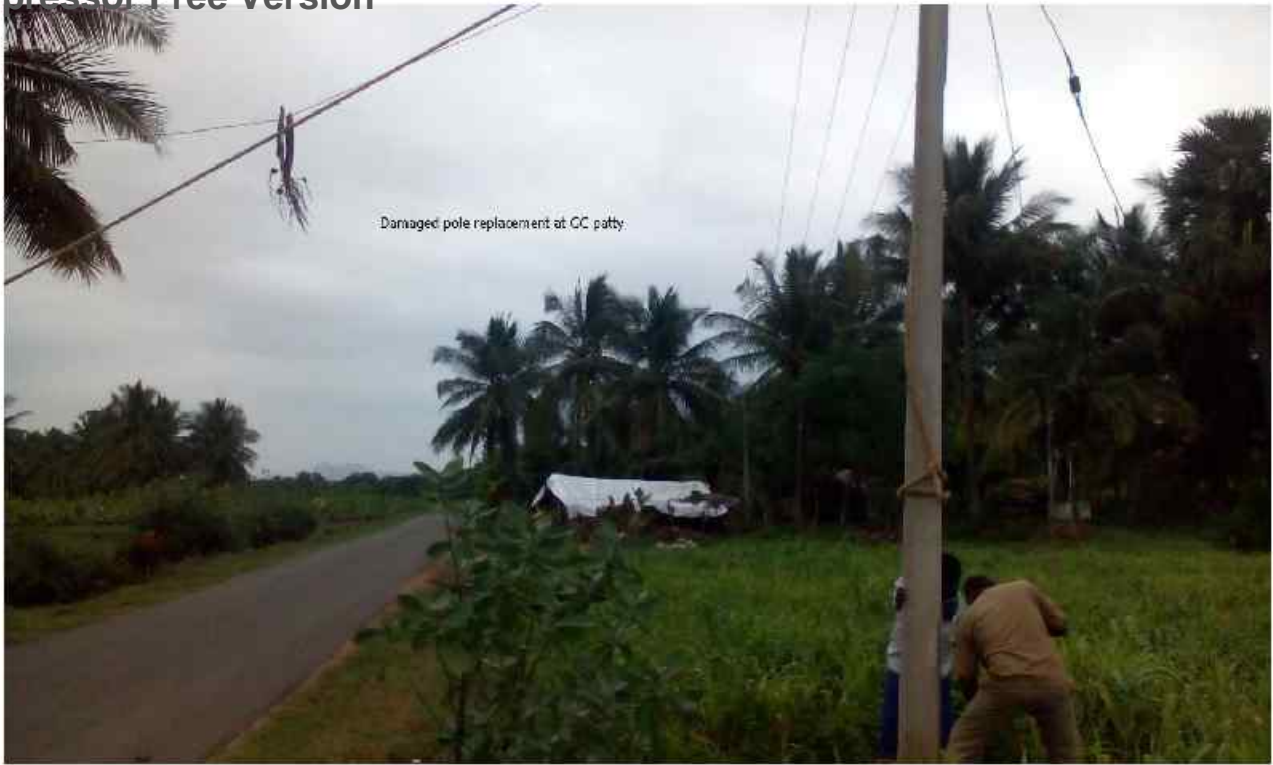
Damaged pole replacement at GC patty.

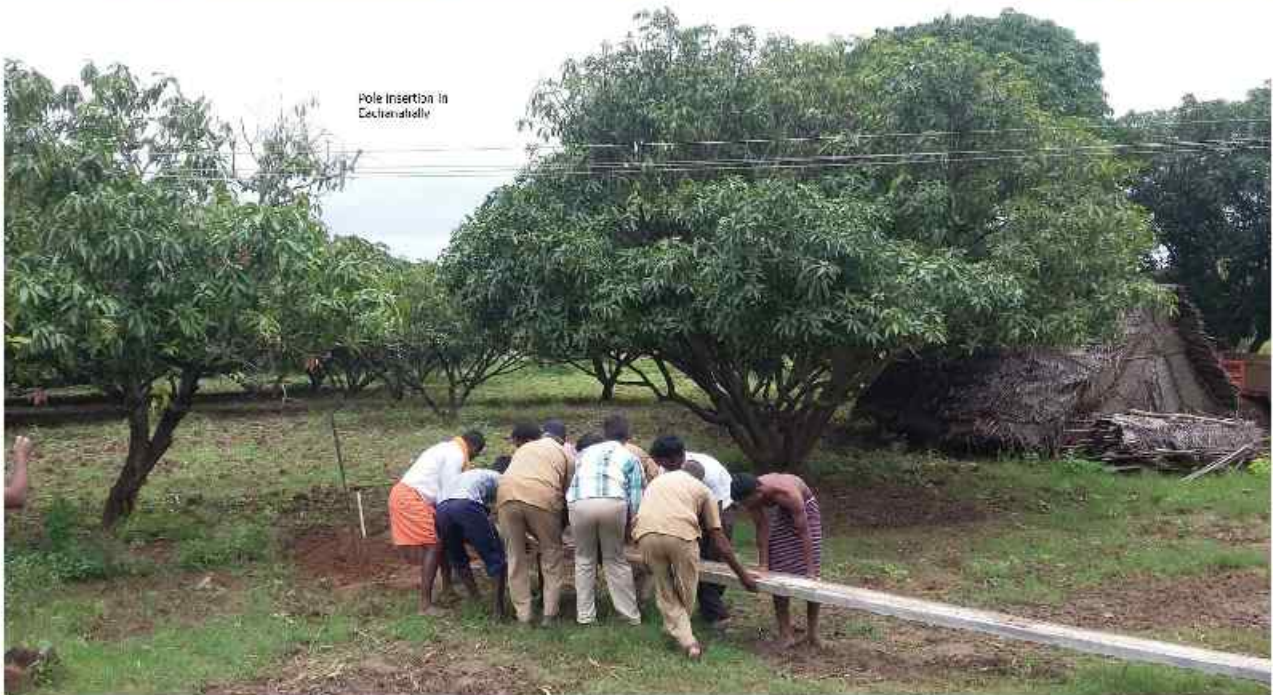
Pole Insertion in  
Centrenahelly

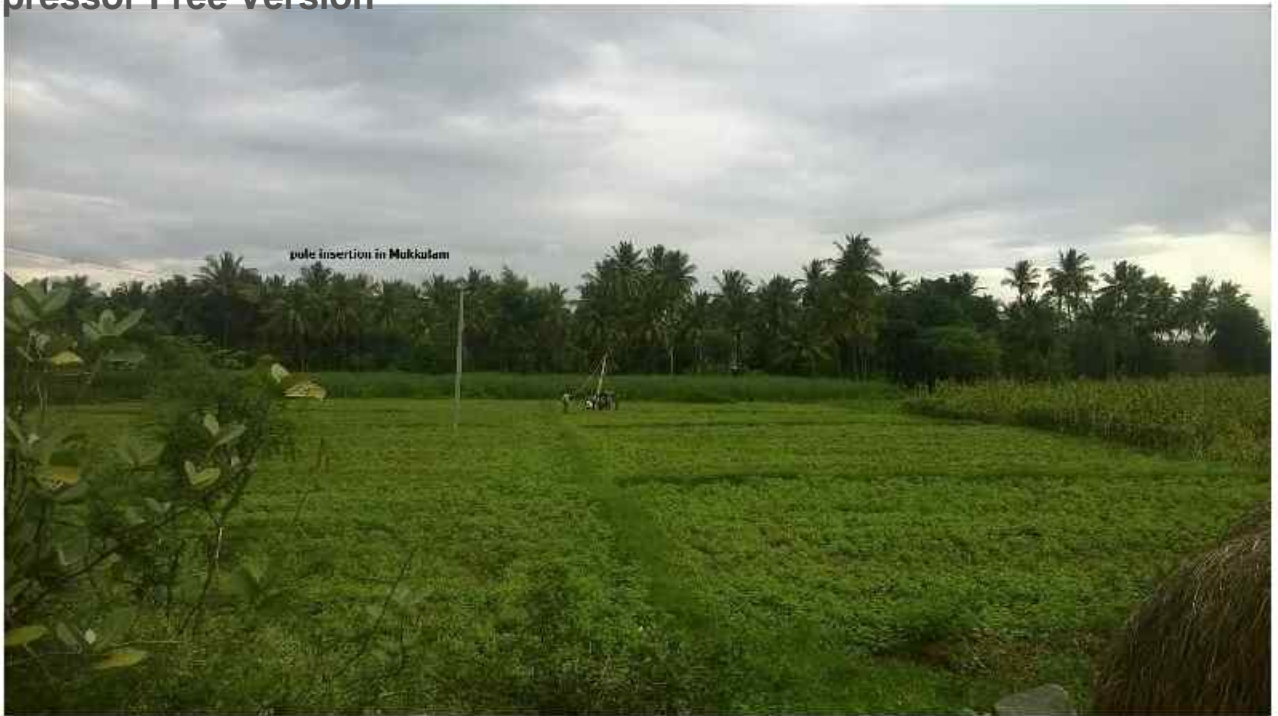
photo insertion in Mukkulam

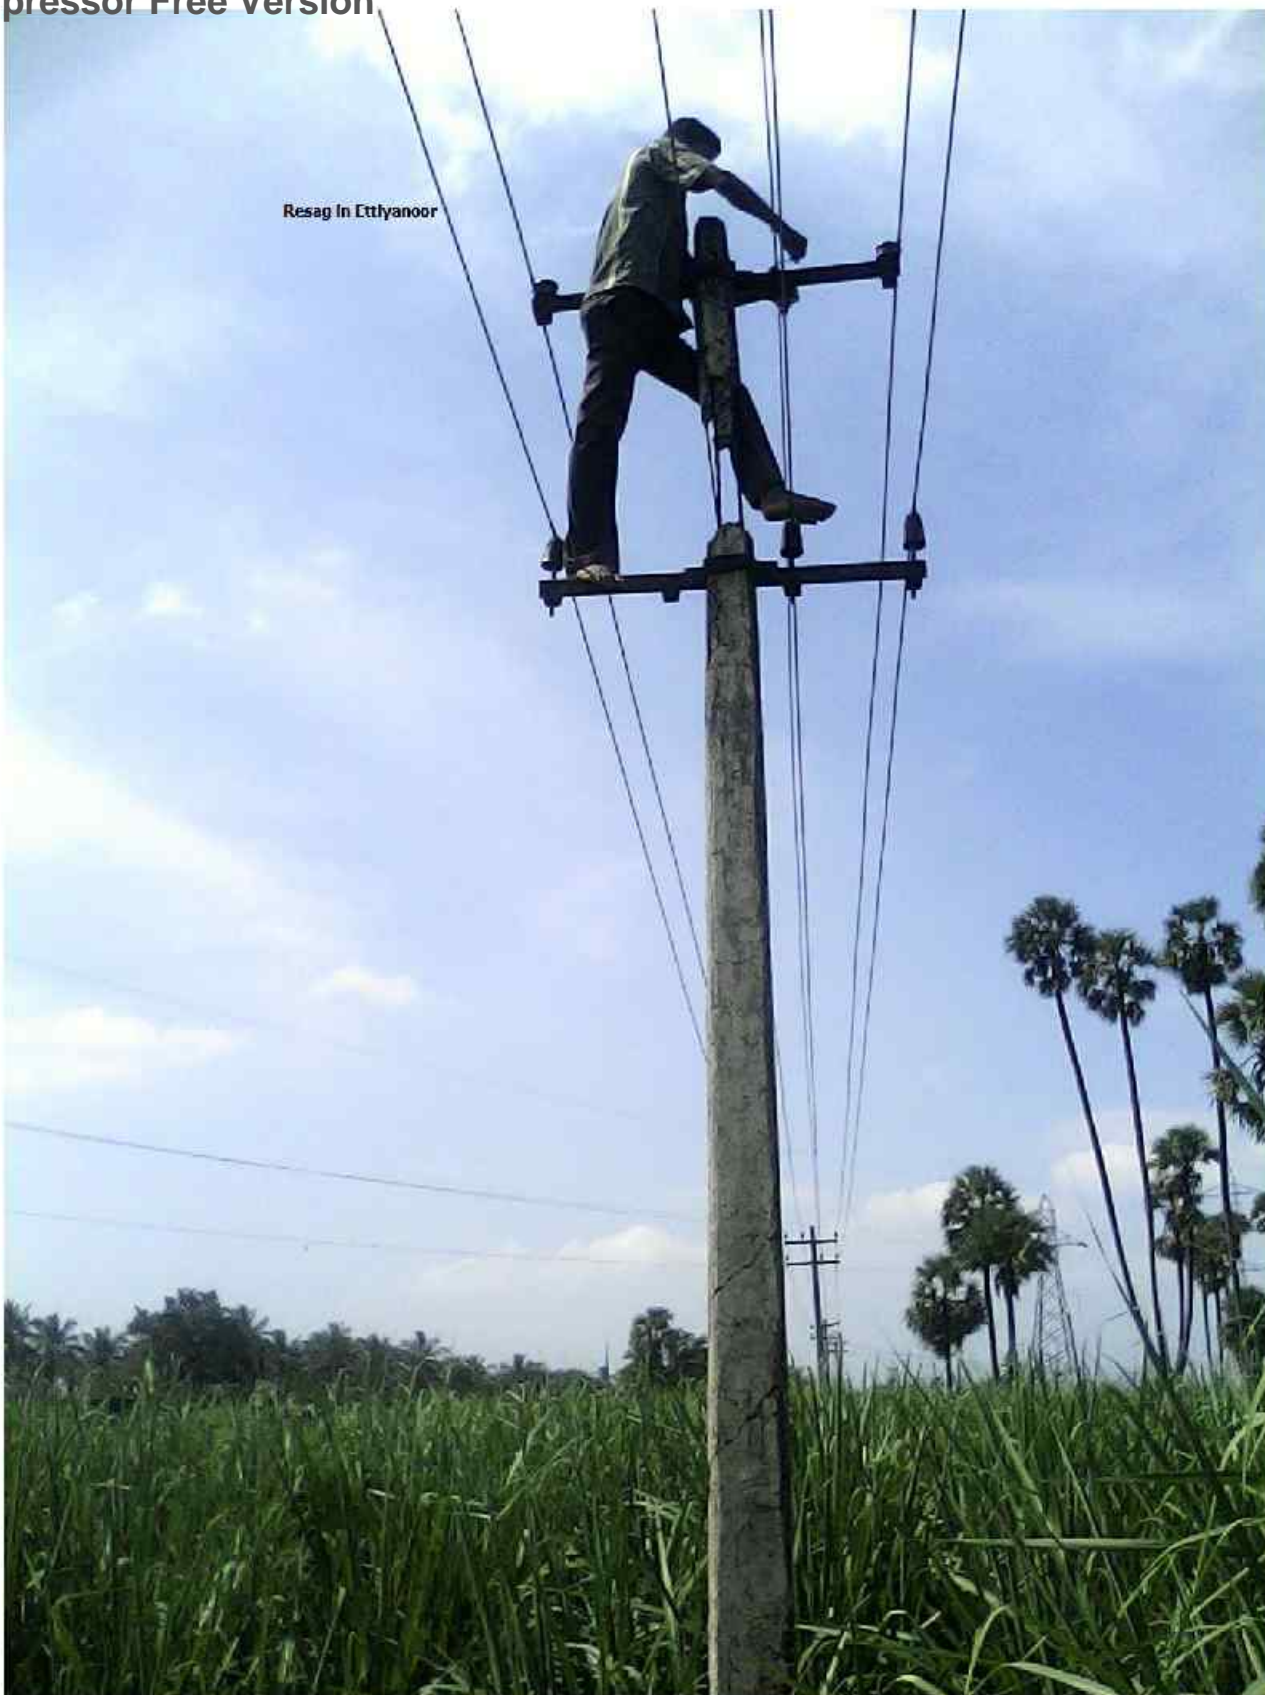
Resag In Etttyanoor
